**PROPERTY CONDITION ASSESSMENT
OF
WORLD TRADE CENTER PORTFOLIO**

ONE WORLD TRADE CENTER

Merritt & Harris, Inc. Project Number 20-251E

Re: **Due Diligence Physical Condition Survey**
World Trade Center
New York, New York

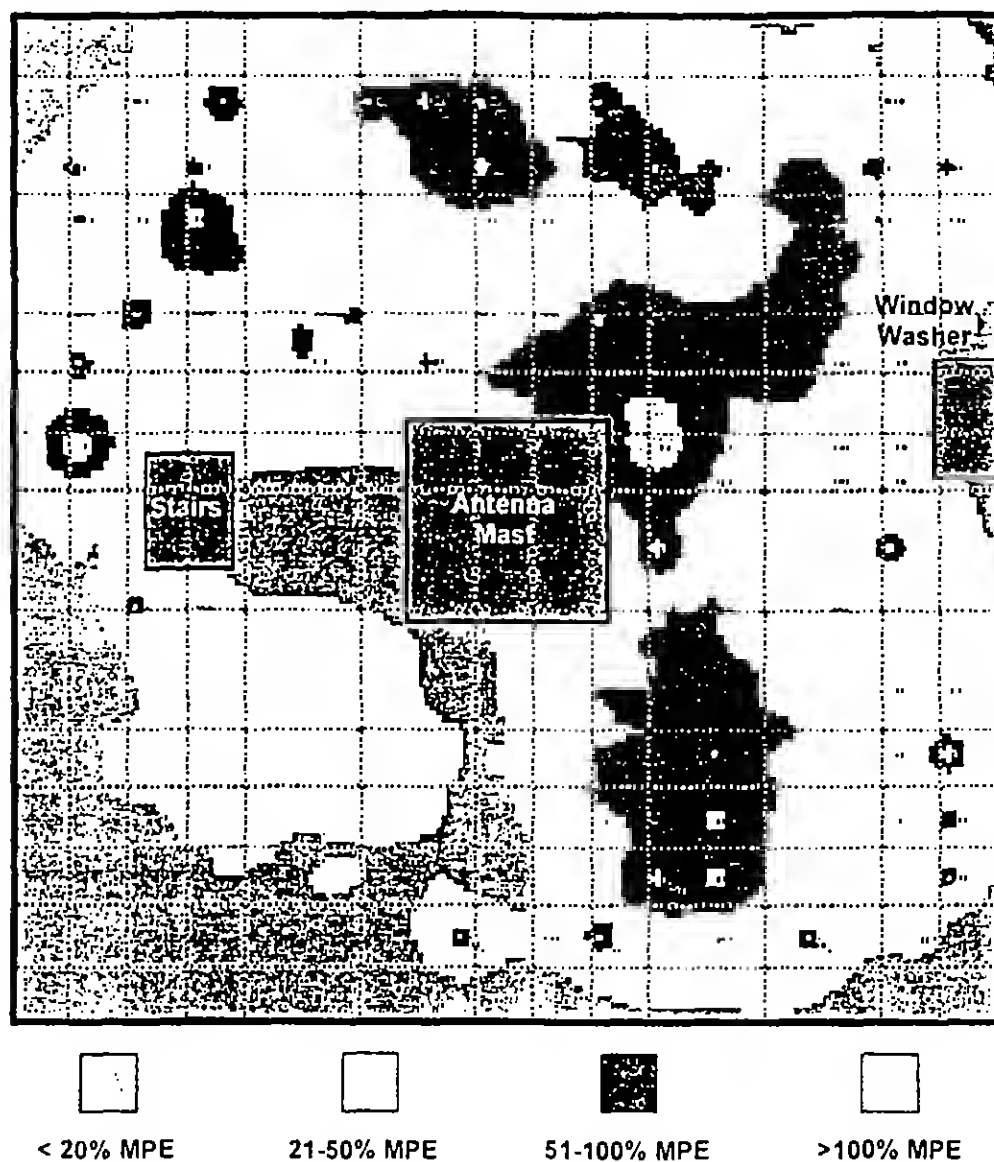
Figure 1. 1999 reevaluation of RF fields from measured ambient fields of normal broadcasting operations with calculated contribution of all wireless telecommunications antennas. Maximum field is 299.6% MPE.

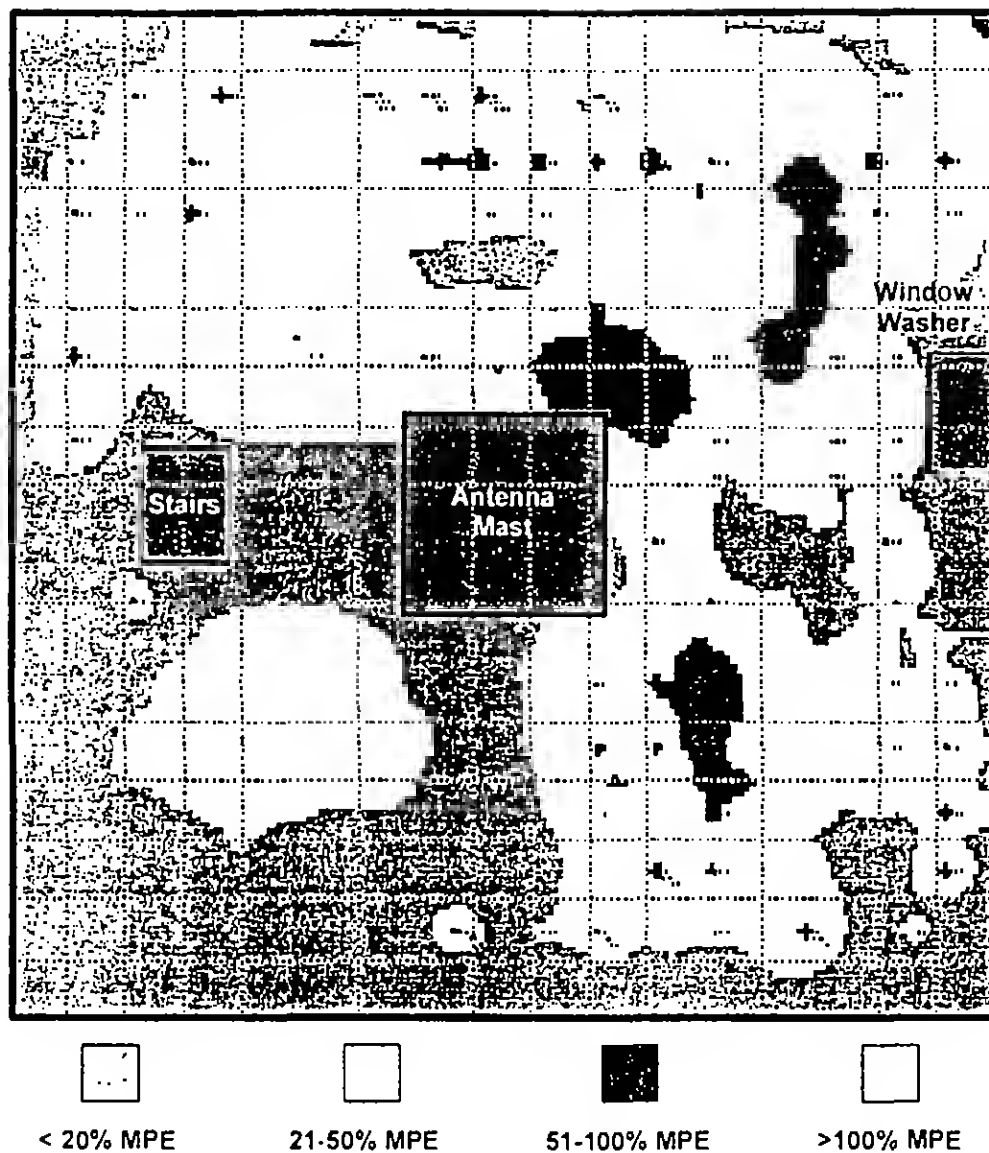
Figure 2. 1999 reevaluation of RF fields from measured ambient fields of normal broadcasting operations with calculated contribution of all wireless telecommunications antennas with selected antennas raised to eliminate fields exceeding MPE. Maximum field is 77.5% MPE.

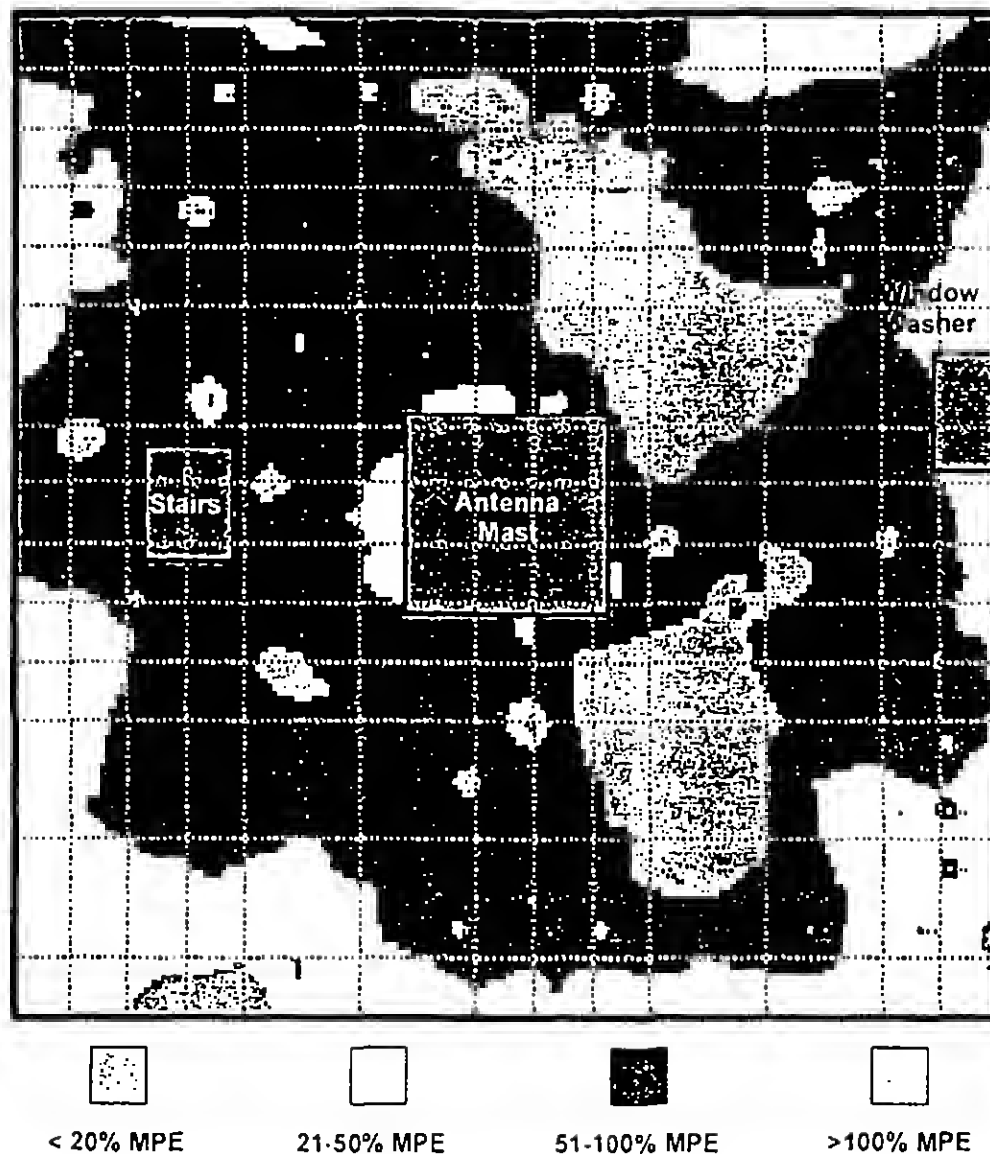
Figure 3. 1999 reanalysis of RF fields from measured ambient fields of tower maintenance broadcasting operations with calculated contribution of all wireless telecommunications antennas. Maximum field is 333.5% MPE.

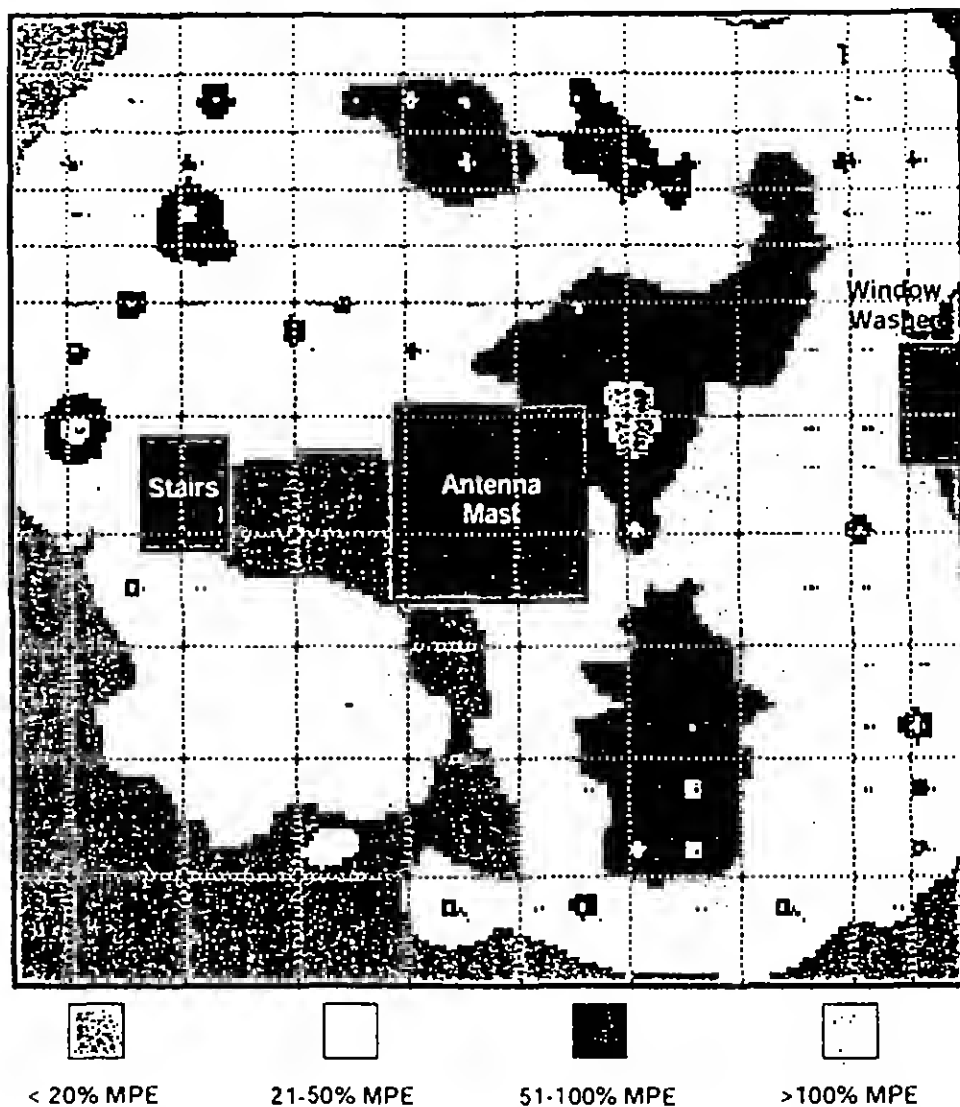
A 1999 reevaluation of RF fields from measured ambient fields of normal broadcasting operations with calculated contribution of all wireless telecommunications antennas (see footnote on page 10). Maximum field is 299.6% MPE.
